**Flood Control Project Maintenance
Levee Inspections**
LMA District Cover Sheet
Spring 2017 Levee Inspection Results

Reclamation District No. 2031 Elliot

Spring 2017 Levee Inspection Results

Waterway			Bank	Unit Miles
Unit No. 01 Stanislaus River			Left	7.07
	Spring (March - May)	Summer (June - August)	(September - November) Fall	Winter (December - February)
Unit Maintenance Rating (Fall Only)				
Date of Inspection	4/25/2017 - 4/25/2017			
DWR Inspector	Maksim Khashchuk			
Accompanied By	Arvid Carlson RD2031

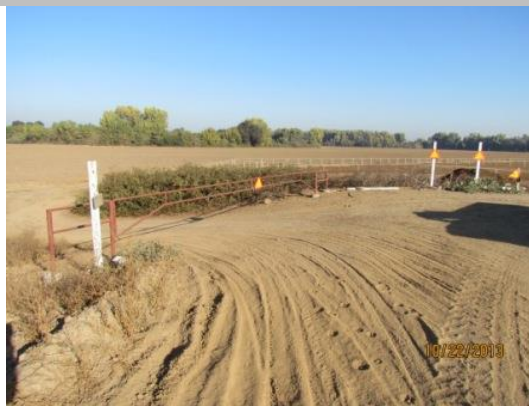
Photo 1 of 1 : SP_2017_RD2031_307_50_20170407_00034.jpg

LM Start	0.06	Rating **	M	Issue No.	50
LM End	0.06	Issue Type +	En	Location *	WS
Category	Earthen Levee			GPS Latitude/Longitude	
				Start	End
Item	Encroachments			37.709950 °	37.709950 °
				-121.156540 °	-121.156540 °
DWR ID	DWR_RD2031_01_f_2013_50				
Comment Code					
FE : Fence					
Inspector Comment					
Unpermitted gates at waterside levee hinge.

View of the gate at the waterside levee hinge.

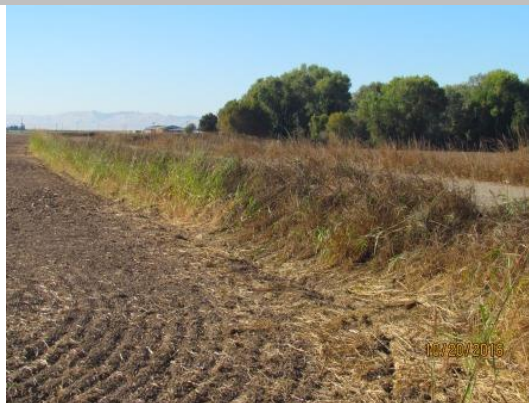
Photo 1 of 1 : SP_2017_RD2031_307_31_20170407_00017.jpg

LM Start	0.07	Rating **	M	Issue No.	31
LM End	0.15	Issue Type +	Ma	Location *	LS
Category	Earthen Levee			GPS Latitude/Longitude	
				Start	End
Item	Vegetation			37.709915 °	37.708707 °
				-121.156548 °	-121.156764 °
DWR ID	DWR_RD2031_01_f_2016_31				
Comment Code					
V1 : Control annual grass and weeds on the levee slopes and easements.					
Inspector Comment

View of the vegetation on the landside levee slope.

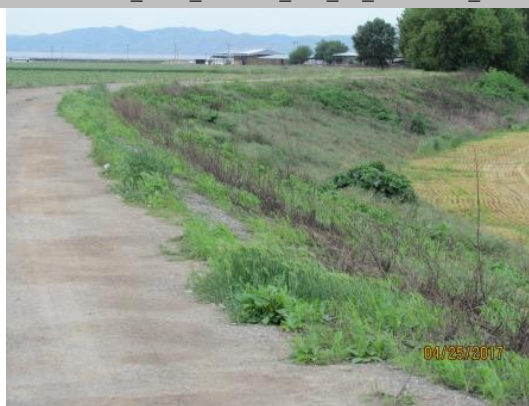
Photo 1 of 1 : SP_2017_RD2031_307_32_20170427_00111.jpg

LM Start	0.17	Rating **	M	Issue No.	32
LM End	0.41	Issue Type +	Ma	Location *	WS
Category	Earthen Levee			GPS Latitude/Longitude	
				Start	End
Item	Vegetation			37.708350 °	37.705155 °
				-121.156856 °	-121.158451 °
DWR ID	DWR_RD2031_01_f_2016_32				
Comment Code					
V1 : Control annual grass and weeds on the levee slopes and easements.					
Inspector Comment

View of the vegetation on the waterside levee slope. Looking downstream.

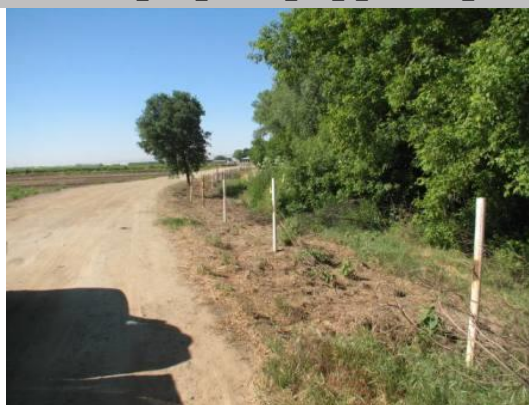
Photo 1 of 3 : SP_2017_RD2031_307_7_20170407_00009.jpg

LM Start	0.34	Rating **	M	Issue No.	7
LM End	0.52	Issue Type +	En	Location *	WS
Category	Earthen Levee			GPS Latitude/Longitude	
				Start	End
Item	Encroachments			37.706148 °	37.704030 °
				-121.157975 °	-121.159653 °
DWR ID	DWR_RD2031_01_s_2012_7				
Comment Code					
FE : Fence					
Inspector Comment					
Fence appears to be completed without CVFPB approval.

05/10/2011 Fence on waterside prevents access to waterside slope.

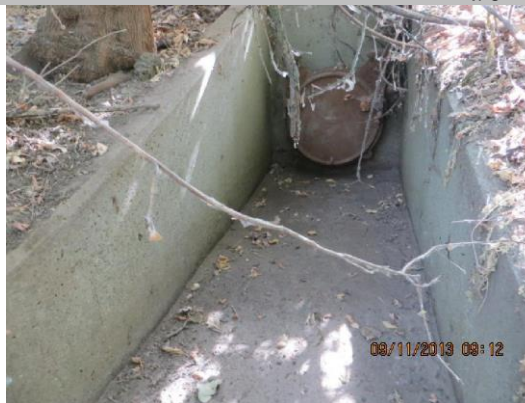
Photo 2 of 2 : UCIP_SP_2017_20024_33923.jpg

LM Start	0.35	Rating **	A/W	Issue No.	983 (cont)
LM End	0.35	Issue Type +	Ma	Location *	WS
Category	Supplemental			GPS Latitude/Longitude	
				Start	End
Item	DWR UCIP LMA Responsibility			37.705932 °	37.705932 °
				-121.157985 °	-121.157985 °
DWR ID					
Comment Code					
Inspector Comment					
FS_ID:20024					
DS_ID:20437					
EP_NO: N/A					
Repair Type: No Action Needed					
Crossing Status: Found					
UCIP Comments:					
FIELD_STRUCT_DESC: 24-inch corrugated metal stormdrain pipe through the levee 3.5-feet below the crown. Concrete "U" headwall on both ends. Flap gate on the waterward end. Installed by UASCE, 1966. Originally included in the 1968 O&M manual.					
FS Date: 9/11/2013

Concrete headwall and flapgate on WS toe.

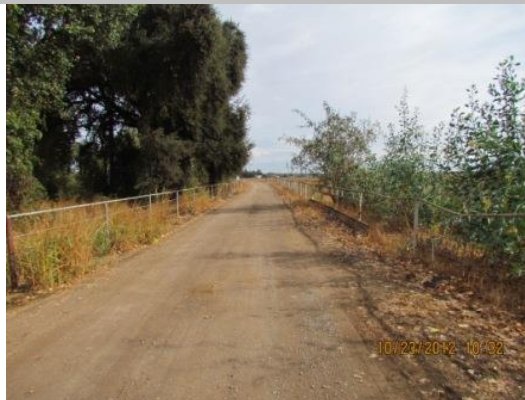
Photo 1 of 2 : SP_2017_RD2031_307_14_20170407_00014.jpg

LM Start	0.44	Rating **	M	Issue No.	14
LM End	0.53	Issue Type +	En	Location *	LS
Category	Earthen Levee			GPS Latitude/Longitude	
				Start	End
Item	Encroachments			37.704927 °	37.703788 °
				-121.158860 °	-121.159923 °
DWR ID	DWR_RD2031_01_f_2012_14				
Comment Code					
FE : Fence					
Inspector Comment					
It appears the fence was completed without CVFPB approval.

View of fence on landside levee shoulder obstructing access to landside slope. Facing upstream.

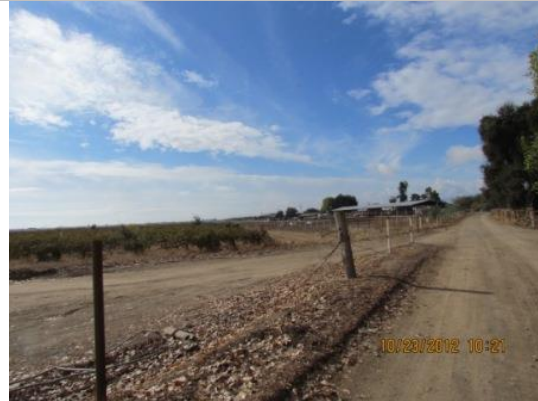
Photo 2 of 2 : SP_2017_RD2031_307_14_20170407_00015.jpg

LM Start	0.44	Rating **	M	Issue No.	14 (cont)	
LM End	0.53	Issue Type +	En	Location *	LS	
Category	Earthen Levee			GPS Latitude/Longitude		
				Start	End	
Item	Encroachments			37.704927 °	37.703788 °	
				-121.158860 °	-121.159923 °	
DWR ID	DWR_RD2031_01_f_2012_14					
Comment Code						
FE : Fence						
Inspector Comment						
It appears the fence was completed without CVFPB approval.

View of fence on landside levee shoulder facing downstream.

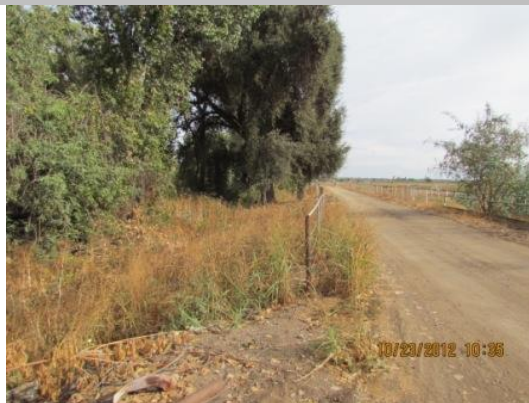
Photo 2 of 3 : SP_2017_RD2031_307_2_20170407_00004.jpg

LM Start	0.48	Rating **	U	Issue No.	2 (cont)
LM End	0.51	Issue Type +	Ma	Location *	WS

View of vegetation on waterside slope. Facing upstream.

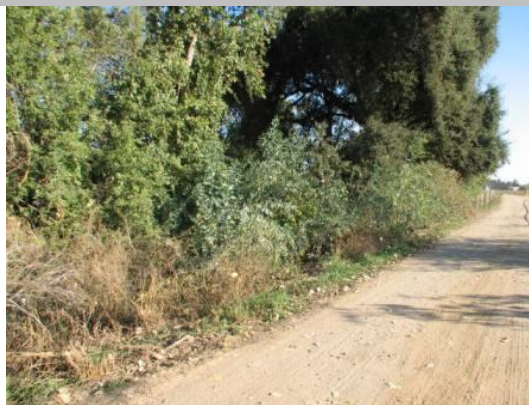
Photo 3 of 3 : SP_2017_RD2031_307_2_20170407_00005.jpg

10/26/2011 Updated photo of waterside vegetation.

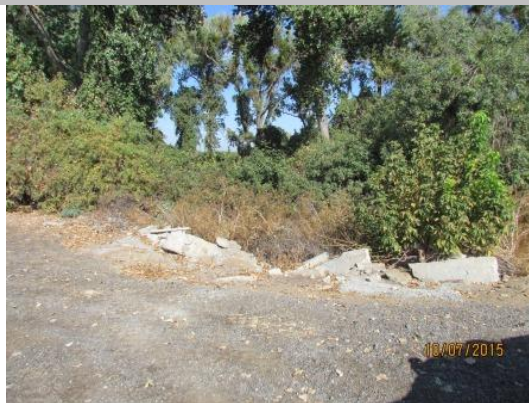
Photo 1 of 1 : SP_2017_RD2031_307_48_20170407_00033.jpg

LM Start	0.51	Rating **	M	Issue No.	48
LM End	0.51	Issue Type +	En	Location *	WS
Category	Earthen Levee			GPS Latitude/Longitude	
				Start	End
Item	Encroachments			37.704041 °	37.704041 °
				-121.159629 °	-121.159629 °
DWR ID	DWR_RD2031_01_f_2015_48				
Comment Code					
MA : Material					
Inspector Comment					
Concrete dumped on the waterside slope.

View of the concrete placed on the waterside levee slope.

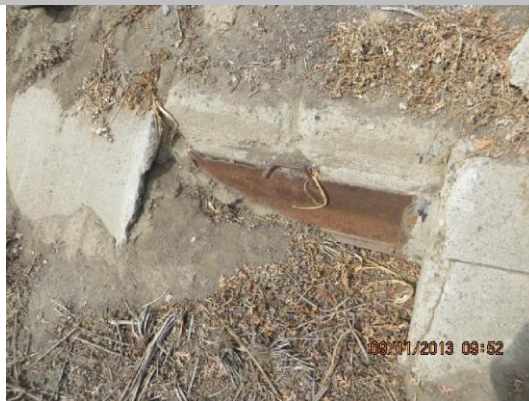
Photo 3 of 3 : UCIP_SP_2017_20047_33948.jpg

LM Start	0.75	Rating **	M	Issue No.	986 (cont)	
LM End	0.75	Issue Type +	En	Location *	LS	
Category	Supplemental			GPS Latitude/Longitude		
				Start	End	
Item	DWR UCIP Field Study			37.701552 °	37.701552 °	
				-121.161883 °	-121.161883 °	
DWR ID						
Comment Code						
Inspector Comment						
FS_ID:20047						
DS_ID:20441						
EP_NO: N/A						
Repair Type: Non-Urgent						
Crossing Status: Found						
UCIP Comments: This pipe appears abandoned and if so, should be done so appropriately.						
FIELD_STRUCT_DESC: 15-inch corrugated metal pipe through levee 4.0 feet below crown. Flashboard slots on the landward side. Installed by USACE 1966. Originally included in the 1968 O&M manual.						
FS Date: 9/11/2013

Closed slidegate at concrete headwall in concrete channel on LS shoulder.

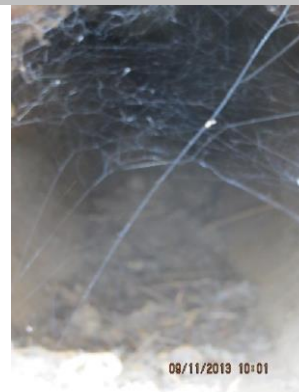
Photo 2 of 3 : UCIP_SP_2017_20049_33955.jpg

LM Start	0.80	Rating **	M	Issue No.	987 (cont)
LM End	0.80	Issue Type +	En	Location *	LS
Category	Supplemental			GPS Latitude/Longitude	
				Start	End
Item	DWR UCIP Field Study			37.700853 °	37.700853 °
				-121.162349 °	-121.162349 °
DWR ID					
Comment Code					
Inspector Comment					
FS_ID:20049					
DS_ID:20443					
EP_NO: N/A					
Repair Type: Non-Urgent					
Crossing Status: Found					
UCIP Comments: Pipe appears abandoned as WS slope is covered with soil. If abadoned, it should be done so properly.					
FIELD_STRUCT_DESC: 24-inch steel pipe through levee 2.0-feet below the crown. Concrete headwall on both sides of levee crown.					
FS Date: 9/11/2013

Pipe not filled with concrete.

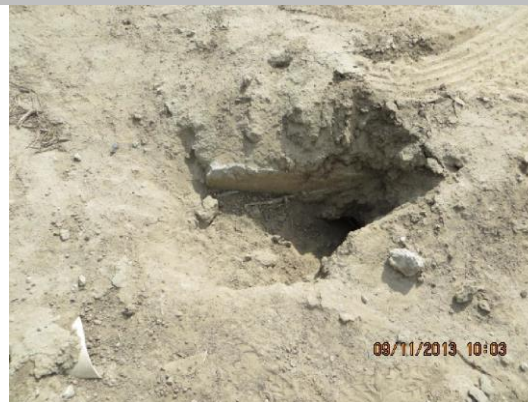
Photo 3 of 3 : UCIP_SP_2017_20049_33954.jpg

Concrete headwall on WS shoulder buried.

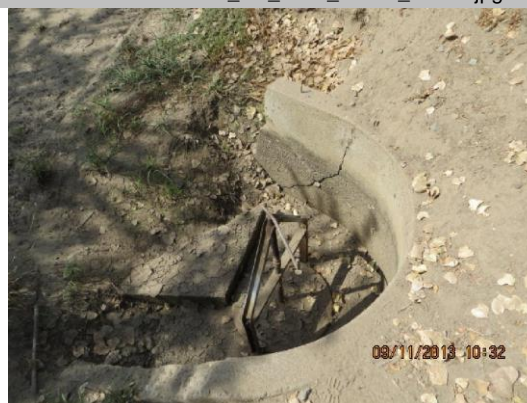
Photo 3 of 3 : UCIP_SP_2017_47158_74942.jpg

LM Start	0.92	Rating **	M	Issue No.	988 (cont)	
LM End	0.92	Issue Type +	En	Location *	CR	
Category	Supplemental			GPS Latitude/Longitude		
				Start	End	
Item	DWR UCIP Field Study			37.699692 °	37.699692 °	
				-121.163977 °	-121.163977 °	
DWR ID						
Comment Code						
Inspector Comment						
FS_ID:47158						
DS_ID:20444						
EP_NO: N/A						
Repair Type: Non-Urgent						
Crossing Status: Indicator Found						
UCIP Comments: Need site visit by UCIP--Concrete headwall present on landward side toe. Need to coordinate with owner to determine if this headwall is for 24-inch pipe or if the structure is part of drainage system that could run parallel to levee.						
FIELD_STRUCT_DESC: 24-inch pipe through levee 3.5 feet below crown. Flap gate on the waterward end.						
FS Date: 9/10/2013

Structure buried with soil--no access.

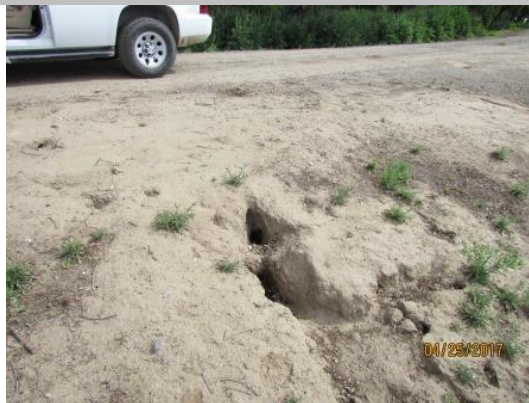
Photo 1 of 2 : SP_2017_RD2031_307_44_20170427_00112.jpg

LM Start	1.16	Rating **	M	Issue No.	44
LM End	1.16	Issue Type +	Ma	Location *	LS
Category	Earthen Levee			GPS Latitude/Longitude	
				Start	End
Item	Animal Control			37.698848 °	37.698848 °
				-121.168088 °	-121.168088 °
DWR ID	DWR_RD2031_01_f_2016_44				
Comment Code					
A3 : No rodents visible, but rodent burrows visible; need to backfill and compact or grout burrows.					
Inspector Comment

View of the rodent holes on the landside levee slope.

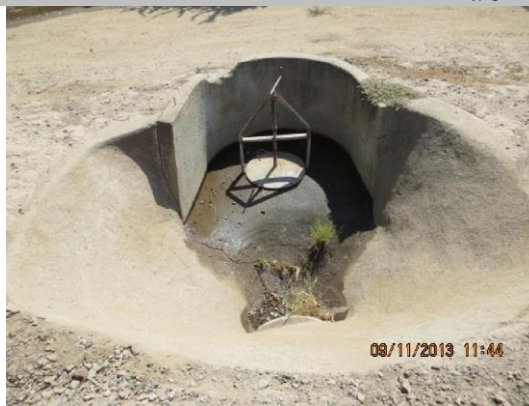
Photo 1 of 3 : UCIP_SP_2017_20088_34030.jpg

LM Start	1.55	Rating **	A/W	Issue No.	990
LM End	1.55	Issue Type +	Ma	Location *	LS
Category	Supplemental			GPS Latitude/Longitude	
				Start	End
Item	DWR UCIP LMA Responsibility			37.698921 °	37.698921 °
				-121.174144 °	-121.174144 °
DWR ID					
Comment Code					
Inspector Comment					
FS_ID:20088 DS_ID:20446 EP_NO: N/A Repair Type: No Action Needed Crossing Status: Found UCIP Comments: FIELD_STRUCT_DESC: 24-inch corrugated metal pipe through the levee 3.5-feet below the crown. Concrete headwalls on both ends. Flap gate on the waterward end. Installed by USACE, 1966. Also included in the 1968 O&M manual. FS Date: 9/11/2013

Bowl shaped concrete inlet on LS slope.

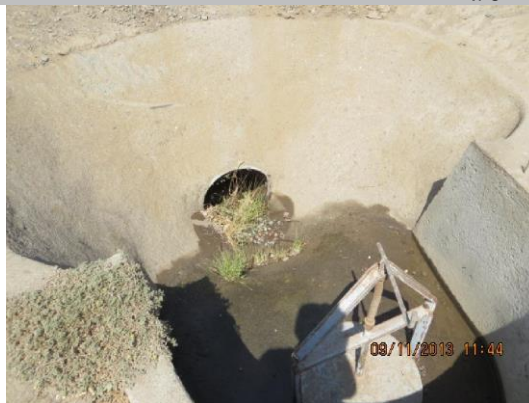
Photo 2 of 3 : UCIP_SP_2017_20088_34029.jpg

LM Start	1.55	Rating **	A/W	Issue No.	990 (cont)	
LM End	1.55	Issue Type +	Ma	Location *	LS	
Category	Supplemental			GPS Latitude/Longitude		
				Start	End	
Item	DWR UCIP LMA Responsibility			37.698921 °	37.698921 °	
				-121.174144 °	-121.174144 °	
DWR ID						
Comment Code						
Inspector Comment						
FS_ID:20088						
DS_ID:20446						
EP_NO: N/A						
Repair Type: No Action Needed						
Crossing Status: Found						
UCIP Comments:						
FIELD_STRUCT_DESC: 24-inch corrugated metal pipe through the						
levee 3.5-feet below the crown. Concrete headwalls on both ends. Flap						
gate on the waterward end. Installed by USACE, 1966. Also included in						
the 1968 O&M manual.						
FS Date: 9/11/2013

Bowl shaped concrete inlet on LS slope.

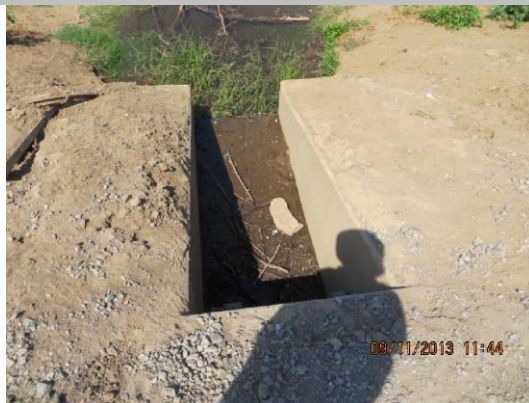
Photo 3 of 3 : UCIP_SP_2017_20088_34028.jpg

Concrete U-shaped headwall on WS slope.

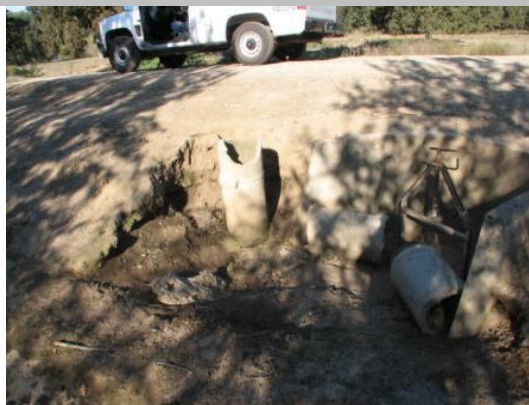
Photo 2 of 2 : SP_2017_RD2031_307_3_20170407_00007.jpg

View of the erosion site on landside slope, facing upstream.

10/26/2011 Active erosion into the levee prism around irrigation standpipe.

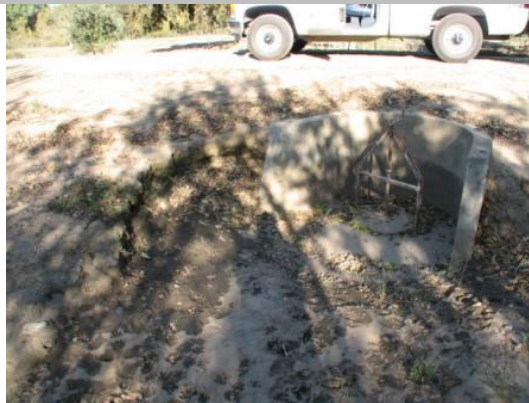
Photo 1 of 1 : SP_2017_RD2031_307_8_20170407_00012.jpg

LM Start	1.58	Rating **	U	Issue No.	8
LM End	1.58	Issue Type +	Ma	Location *	WS
Category	Earthen Levee			GPS Latitude/Longitude	
				Start	End
Item	Erosion / Bank Caving			37.698610 °	37.698610 °
				-121.174598 °	-121.174598 °
DWR ID	DWR_RD2031_01_s_2012_8				
Comment Code					
E1 : Note and monitor erosion site.					
Inspector Comment					
Active erosion is occurring around irrigation inlet.

10/26/2011 Active erosion shown around irrigation inlet.

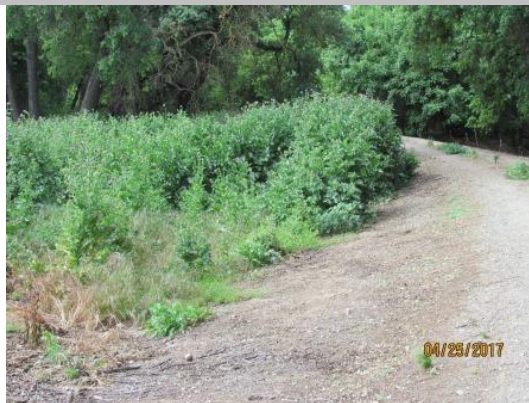
Photo 1 of 2 : SP_2017_RD2031_307_29_20170427_00115.jpg

LM Start	1.73	Rating **	U	Issue No.	29
LM End	1.86	Issue Type +	Ma	Location *	LS
Category	Earthen Levee			GPS Latitude/Longitude	
				Start	End
Item	Vegetation			37.697477 °	37.695818 °
				-121.176953 °	-121.177542 °
DWR ID	DWR_RD2031_01_s_2016_29				
Comment Code					
V2 : Remove the wild growth other than native grasses from the levee slopes.					
Inspector Comment					
Maintain vegetation 12 inches tall or less on levee slope and within 10 feet of levee toe.

View of the tall vegetation on the landside levee slope.

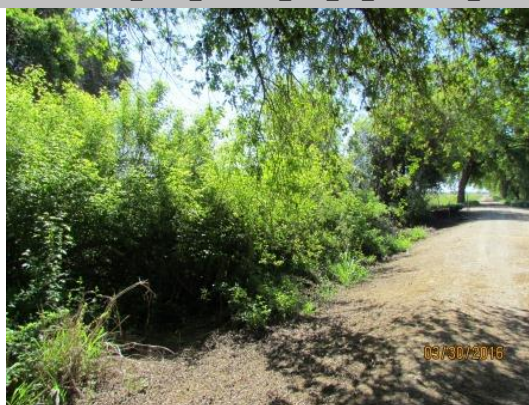
Photo 2 of 2 : SP_2017_RD2031_307_29_20170407_00016.jpg

Another view of the tall vegetation on the landside levee slope.

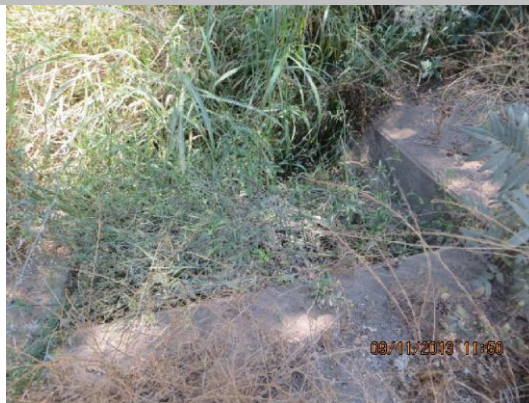
Photo 2 of 3 : UCIP_SP_2017_41354_34033.jpg

Concrete headwall on LS toe.

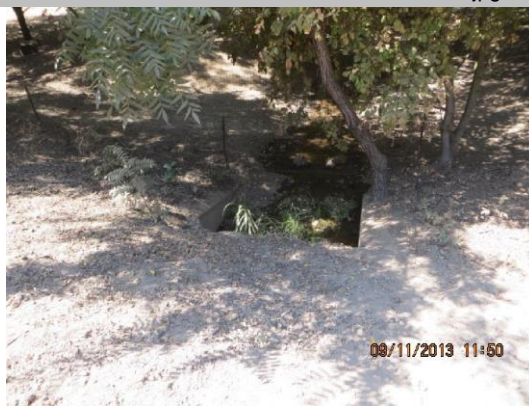
Photo 1 of 3 : UCIP_SP_2017_20092_34041.jpg

LM Start	1.78	Rating **	M	Issue No.	992
LM End	1.78	Issue Type +	Ma	Location *	LS
Category	Supplemental			GPS Latitude/Longitude	
				Start	End
Item	DWR UCIP LMA Responsibility			37.696943 °	37.696943 °
				-121.177470 °	-121.177470 °
DWR ID					
Comment Code					
Inspector Comment					
FS_ID:20092 DS_ID:20447 EP_NO: N/A Repair Type: Non-Urgent Crossing Status: Found UCIP Comments: Silt buildup at inlet and outlet. FIELD_STRUCT_DESC: 2 of 2: 24-inch corrugated metal pipe through the levee 9.5-feet below the crown. Concrete "U"-shaped headwalls on both ends. Flap gate on the waterward end. Installed by USACE, 1966. Also included in the 1968 O&M manual. FS Date: 9/11/2013

Concrete U-shaped headwall on WS toe.

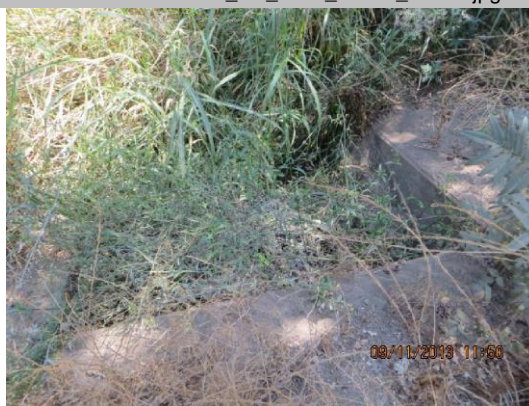
Photo 2 of 3 : UCIP_SP_2017_20092_34040.jpg

Concrete U-shaped headwall on LS toe.

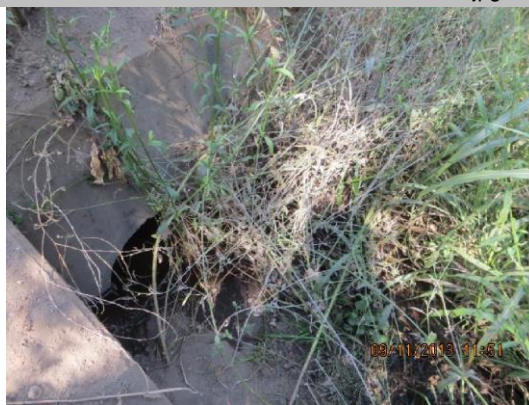
Photo 3 of 3 : UCIP_SP_2017_20092_34039.jpg

Concrete U-shaped headwall on LS toe.

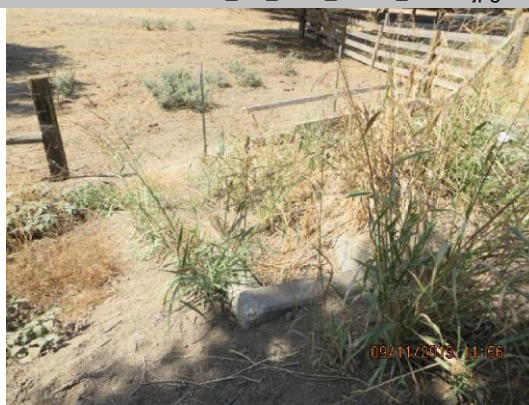
Photo 1 of 3 : UCIP_SP_2017_20109_34075.jpg

LM Start	1.86	Rating **	M	Issue No.	993
LM End	1.86	Issue Type +	En	Location *	WS
Category	Supplemental			GPS Latitude/Longitude	
				Start	End
Item	DWR UCIP Field Study			37.695737 °	37.695737 °
				-121.177533 °	-121.177533 °
DWR ID					
Comment Code					
Inspector Comment					
FS_ID:20109 DS_ID:20448 EP_NO: N/A Repair Type: Non-Urgent Crossing Status: Found UCIP Comments: If abandoned it should be done so properly if not, the pipe should be cleared of soil blockage. FIELD_STRUCT_DESC: *ABANDONED* 24-inch pipe through levee 6.8 feet below crown. Concrete headwalls on both ends. Flap gate on the waterward end. Installed by USACE, 1966. FS Date: 9/11/2013

Concrete U-shaped headwall on WS toe.

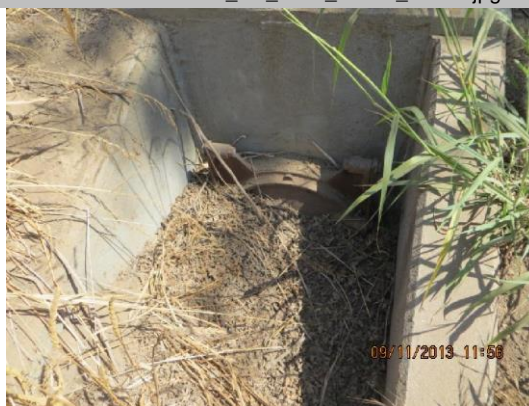
Photo 2 of 3 : UCIP_SP_2017_20109_34074.jpg

FS_ID:20109
DS_ID:20448
EP_NO: N/A
Repair Type: Non-Urgent
Crossing Status: Found
UCIP Comments: If abandoned it should be done so properly if not, the pipe should be cleared of soil blockage.
FIELD_STRUCT_DESC: *ABANDONED* 24-inch pipe through levee 6.8 feet below crown. Concrete headwalls on both ends. Flap gate on the waterward end. Installed by USACE, 1966.
FS Date: 9/11/2013

Flapgate on WS toe.

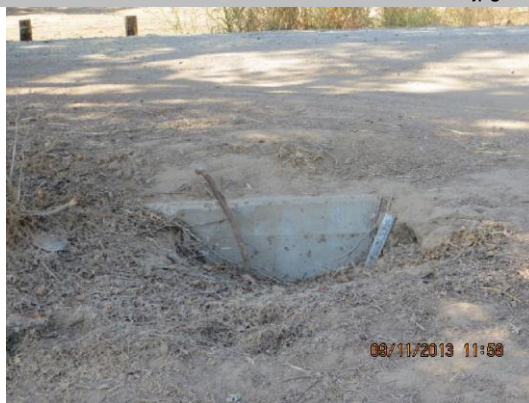
Photo 3 of 3 : UCIP_SP_2017_20109_34073.jpg

Concrete headwall on LS shoulder.

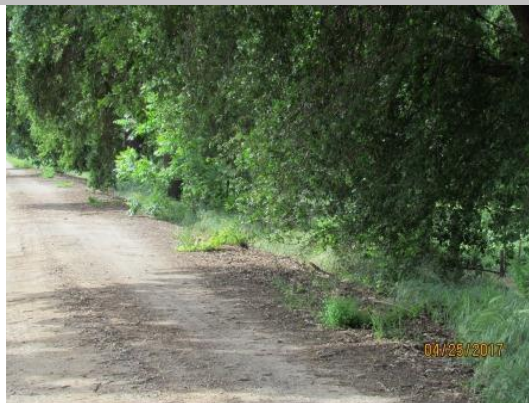
Photo 1 of 1 : SP_2017_RD2031_307_64_20170427_00116.jpg

LM Start	1.89	Rating **	M	Issue No.	64
LM End	1.96	Issue Type +	Ma	Location *	WS
Category	Earthen Levee			GPS Latitude/Longitude	
				Start	End
Item	Trim / Thin Trees			37.695385 °	37.694356 °
				-121.177521 °	-121.177528 °
DWR ID	DWR_RD2031_01_s_2017_64				
Comment Code					
T1 : Trim trees to at least five feet above ground level.					
Inspector Comment

View of the trees that need to be trimmed.

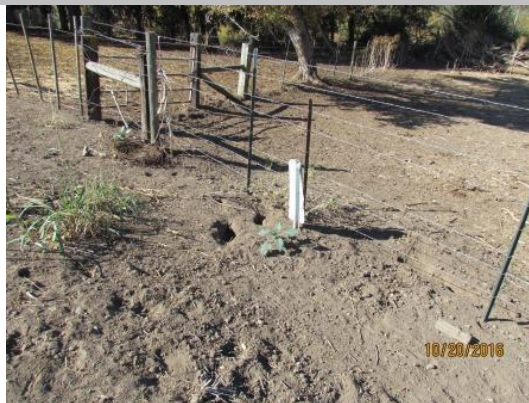
Photo 1 of 1 : SP_2017_RD2031_307_47_20170407_00032.jpg

LM Start	2.14	Rating **	M	Issue No.	47
LM End	2.14	Issue Type +	Ma	Location *	WS
Category	Earthen Levee			GPS Latitude/Longitude	
				Start	End
Item	Animal Control			37.691887 °	37.691887 °
				-121.178127 °	-121.178127 °
DWR ID	DWR_RD2031_01_f_2016_47				
Comment Code					
A1 : Exterminate rodents and backfill and compact or grout burrows.					
Inspector Comment

View of the rodent holes on the waterside levee slope.

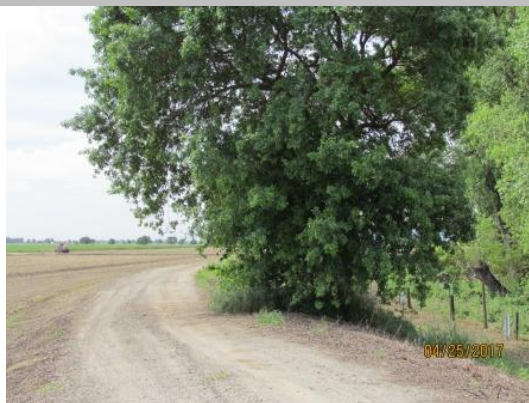
Photo 1 of 1 : SP_2017_RD2031_307_65_20170427_00117.jpg

LM Start	2.24	Rating **	M	Issue No.	65	
LM End	2.24	Issue Type +	Ma	Location *	WS	
Category	Earthen Levee			GPS Latitude/Longitude		
				Start		End
Item	Trim / Thin Trees			37.690438 °		37.690438 °
				-121.178576 °		-121.178576 °
DWR ID	DWR_RD2031_01_s_2017_65					
Comment Code						
T1 : Trim trees to at least five feet above ground level.						
Inspector Comment

View of the tree that needs to be trimmed.

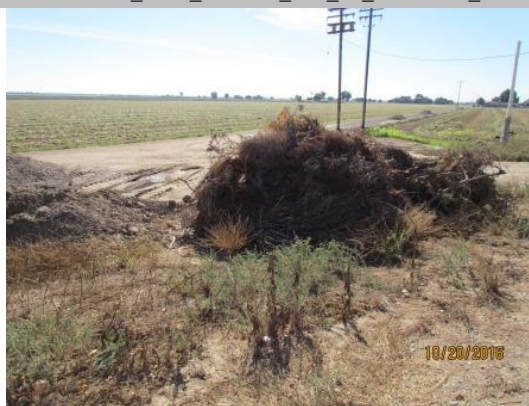
Photo 2 of 2 : SP_2017_RD2031_307_53_20170407_00038.jpg

LM Start	2.40	Rating **	M	Issue No.	53 (cont)	
LM End	2.44	Issue Type +	En	Location *	LS	
Category	Earthen Levee			GPS Latitude/Longitude		
				Start		End
Item	Encroachments			37.688465 °	37.688064 °	
				-121.179821 °	-121.180175 °	
DWR ID	DWR_RD2031_01_s_2015_53					
Comment Code						
DE : Debris						
Inspector Comment

View of another debris pile in close proximity of the previous photo.

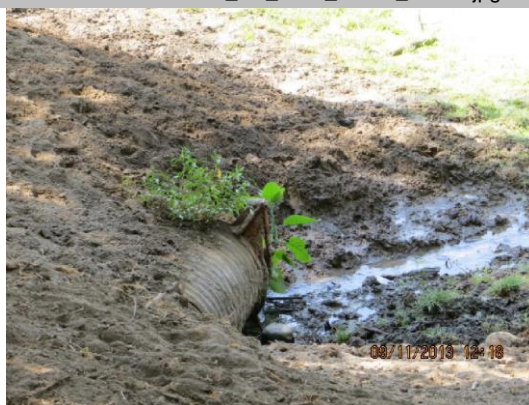
Photo 1 of 3 : UCIP_SP_2017_51340_39002.jpg

Comment Code					
Inspector Comment					
FS_ID:51340 DS_ID:24669 EP_NO: N/A Repair Type: Non-Urgent Crossing Status: Found UCIP Comments: 11/16/2016 No access to WS due to cattle fence in place. Need to coordinate with property owner to obtain access on WS. Unable to find inlet on LS. Reommend internal inspection of crossing. Crossing has been downgraded from Urgent to Non-Urgent no signs of leaks where present on crown or slopes where pipe should be. (O. Magana - DWR UCIP)09/11/2013 Flapgate partially blocked by soil on WS toe. Good candidate for video inspection. (W. Wylie - DWR UCIP) FIELD_STRUCT_DESC: 24-inch corrugated metal drainage pipe through the levee at an unknown depth. Flapgate is located on the waterside (WS) toe. Pipe may originate at concrete distribution box on LS toe. FS Date: 11/16/2016

Flapgate and pipe visible on WS toe.

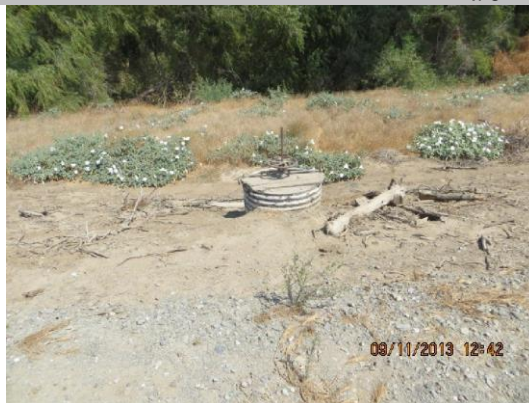
Photo 1 of 3 : UCIP_SP_2017_20449_34506.jpg

FS_ID:20449
DS_ID:20451
EP_NO: N/A
Repair Type: Non-Urgent
Crossing Status: Found
UCIP Comments: Pipe appears to be abandoned and if so should be done so properly.
FIELD_STRUCT_DESC: *ABANDONED* 24-inch corrugated metal pipe through levee 14.0 feet below crown. Slide gate in 36-inch corrugated metal pipe riser on the waterward slope. Originally included in the 1968 O&M manual.
FS Date: 9/11/2013

Slide gate in CMP riser on WS slope.

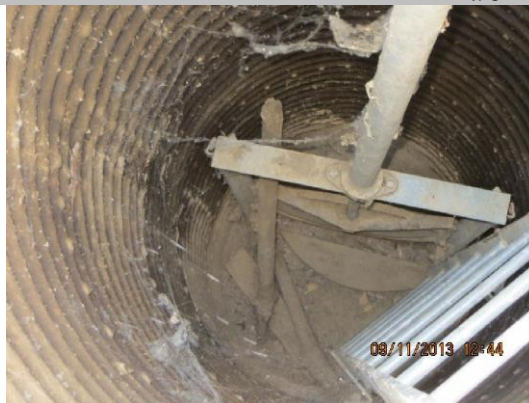
Photo 3 of 3 : UCIP_SP_2017_20449_34504.jpg

Slide gate in CMP riser on WS slope.

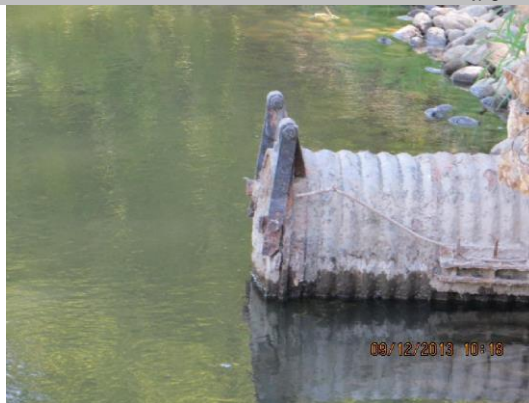
Photo 2 of 2 : UCIP_SP_2017_23064_39199.jpg

LM Start	3.66	Rating **	M	Issue No.	997 (cont)
LM End	3.66	Issue Type +	Ma	Location *	LS
Category	Supplemental			GPS Latitude/Longitude	
				Start	End
Item	DWR UCIP LMA Responsibility			37.689900 °	37.689900 °
				-121.198319 °	-121.198319 °
DWR ID					
Comment Code					
Inspector Comment					
FS_ID:23064 DS_ID:20478 EP_NO: N/A Repair Type: Non-Urgent Crossing Status: Found UCIP Comments: Good candidate for video inspection. FIELD_STRUCT_DESC: 24-inch CMP drainpipe through levee 5.5 feet below crown. Flapgate visilbe at WS toe. Originally included in the 1968 O&M manual. FS Date: 9/12/2013

CMP pipe and flapgate visible at WS toe.

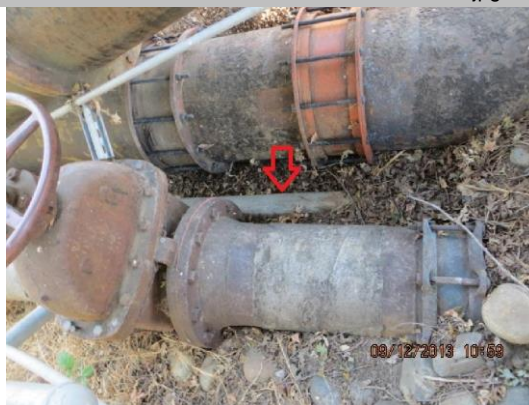
Photo 1 of 2 : UCIP_SP_2017_22843_39015.jpg

LM Start	3.69	Rating **	M	Issue No.	998
LM End	3.69	Issue Type +	En	Location *	LS
Category	Supplemental			GPS Latitude/Longitude	
				Start	End
Item	DWR UCIP Field Study			37.689742 °	37.689742 °
				-121.198778 °	-121.198778 °
DWR ID					
Comment Code					
Inspector Comment					
FS_ID:22843 DS_ID:24672 EP_NO: N/A Repair Type: Non-Urgent Crossing Status: Found UCIP Comments: No permit identified for this possible crossing. FIELD_STRUCT_DESC: 4-inch steel irrigation line through the levee at unknown depth. Pipe visible between larger irrigation pipes below slant pump on WS slope. FS Date: 9/12/2013

Pipe visible between larger irrigation pipes below slant pump on WS slope.

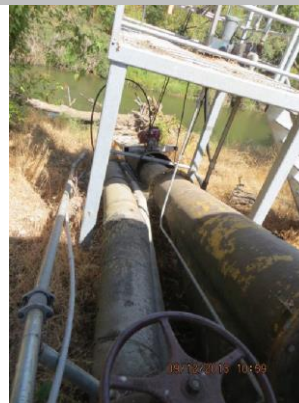
Photo 2 of 2 : UCIP_SP_2017_22843_39014.jpg

Pipe visible between larger irrigation pipes below slant pump on WS slope.

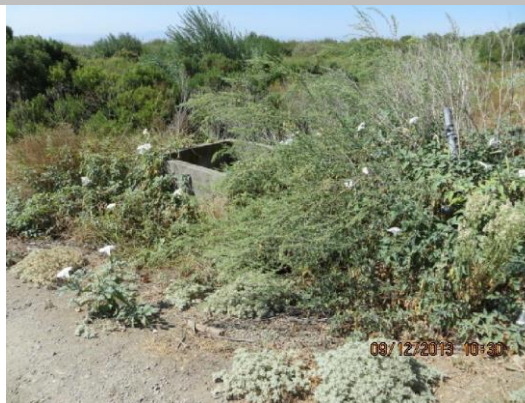
Photo 1 of 3 : UCIP_SP_2017_20667_34750.jpg

LM Start	3.69	Rating **	M	Issue No.	999
LM End	3.69	Issue Type +	En	Location *	LS
Category	Supplemental			GPS Latitude/Longitude	
				Start	End
Item	DWR UCIP Field Study			37.689739 °	37.689739 °
				-121.198790 °	-121.198790 °
DWR ID					
Comment Code					
Inspector Comment					
FS_ID:20667 DS_ID:20456 EP_NO: N/A Repair Type: Non-Urgent Crossing Status: Found UCIP Comments: Siphon breaker missing from LS shoulder. Fish screen and pipe end covered in debris that may cause damage to pipe. FIELD_STRUCT_DESC: 1 of 2: 20-inch steel irrigation pipe through levee 3.9 feet below crown. Slant pump in pump house mounted on piles on the berm. Siphon breaker in corrugated metal pipe riser on the landward shoulder. Service pole on the landward slope. 5'X5' concrete distribution box on LS toe with flapgate. Originally included in the 1968 O&M manual. FS Date: 9/12/2013

Concrete distribution box on LS slope.

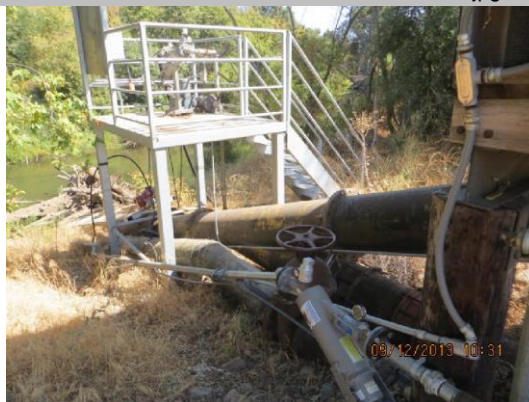
Photo 3 of 3 : UCIP_SP_2017_20667_34748.jpg

Pipe with debris flow buildup at inlet visible on WS toe.

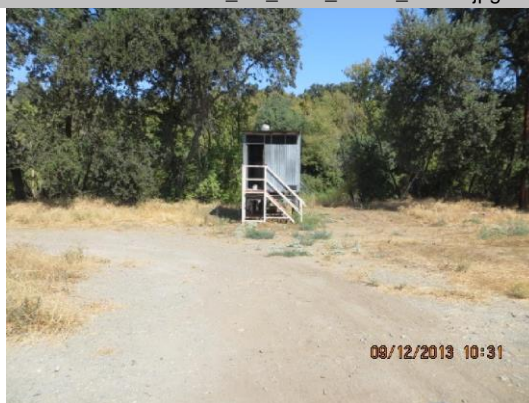
Photo 1 of 3 : UCIP_SP_2017_22845_39021.jpg

FS_ID:22845
DS_ID:24671
EP_NO: N/A
Repair Type: Non-Urgent
Crossing Status: Found
UCIP Comments: No permit identified for this possible crossing.
FIELD_STRUCT_DESC: 2.5-inch galvanized iron irrigation line through the levee at unknown depth. Submersible pump at WS slope.
FS Date: 9/12/2013

Pipe visible on WS of pumphouse.

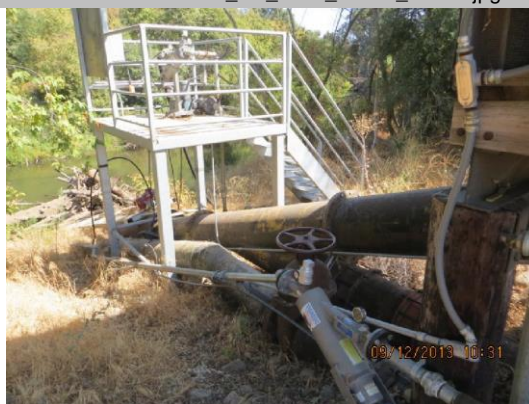
Photo 2 of 3 : UCIP_SP_2017_22845_39020.jpg

Pipe and appurtenances visible on downstream side of and next to larger irrigation pipe.

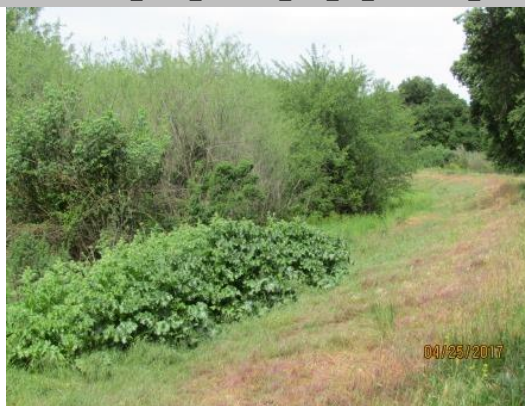
Photo 1 of 4 : SP_2017_RD2031_307_33_20170427_00122.jpg

LM Start	3.69	Rating **	U	Issue No.	33
LM End	4.38	Issue Type +	Ma	Location *	LS
Category	Earthen Levee			GPS Latitude/Longitude	
				Start	End
Item	Vegetation			37.689718 °	37.686658 °
				-121.198833 °	-121.207747 °
DWR ID	DWR_RD2031_01_f_2016_33				
Comment Code					
V2 : Remove the wild growth other than native grasses from the levee slopes.					
Inspector Comment					
Trim back woody vegetation at least 15 feet away from the landside levee toe.

View of the vegetation at the levee toe and slope.

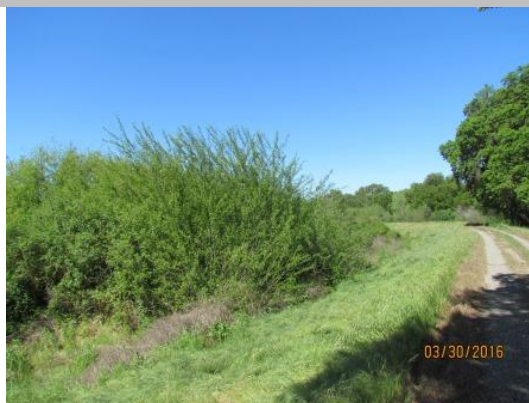
Photo 3 of 4 : SP_2017_RD2031_307_33_20170407_00019.jpg

View of the tall vegetation on the landside levee slope and toe.

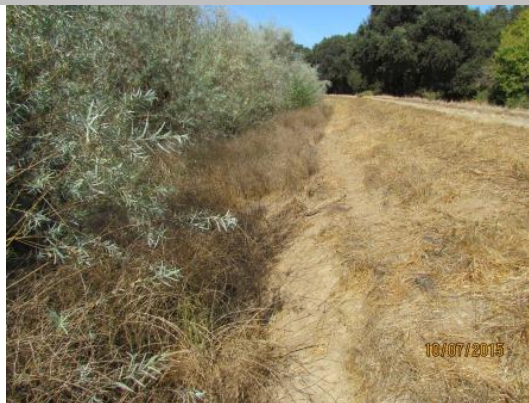
Photo 1 of 1 : SP_2017_RD2031_307_57_20170407_00040.jpg

LM Start	3.78	Rating **	M	Issue No.	57
LM End	3.81	Issue Type +	Ma	Location *	LS
Category	Earthen Levee			GPS Latitude/Longitude	
				Start	End
Item	Erosion / Bank Caving			37.690302 °	37.690664 °
				-121.200232 °	-121.200549 °
DWR ID	DWR_RD2031_01_f_2015_57				
Comment Code					
E2 : Schedule repair of erosion site prior to the next inspection.					
Inspector Comment					
Erosion at the landside levee toe.

View of the 18 inch vertical cut at the landside levee toe.

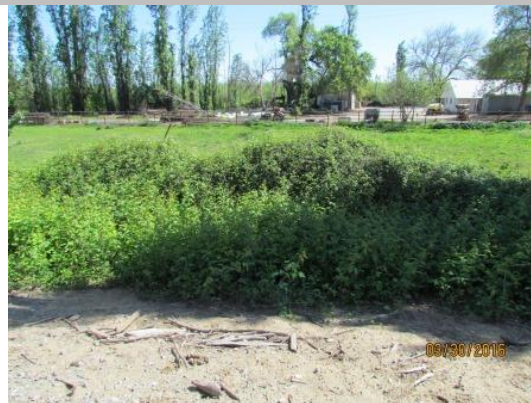
Photo 1 of 1 : SP_2017_RD2031_307_43_20170407_00028.jpg

LM Start	4.52	Rating **	U	Issue No.	43
LM End	4.52	Issue Type +	Ma	Location *	LS
Category	Earthen Levee			GPS Latitude/Longitude	
				Start	End
Item	Vegetation			37.684988 °	37.684988 °
				-121.208366 °	-121.208366 °
DWR ID	DWR_RD2031_01_s_2016_43				
Comment Code					
V2 : Remove the wild growth other than native grasses from the levee slopes.					
Inspector Comment

View of the tall vegetation on the landside levee slope and toe.

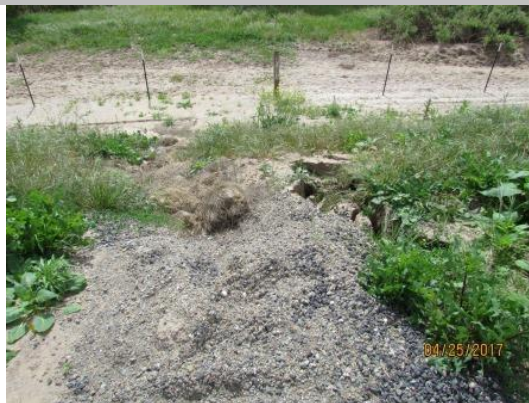
Photo 1 of 1 : SP_2017_RD2031_307_71_20170427_00124.jpg

LM Start	5.01	Rating **	M	Issue No.	71
LM End	5.01	Issue Type +	Ma	Location *	LS
Category	Earthen Levee			GPS Latitude/Longitude	
				Start	End
Item	Erosion / Bank Caving			37.679712 °	37.679712 °
				-121.212613 °	-121.212613 °
DWR ID	DWR_RD2031_01_s_2017_71				
Comment Code					
E2 : Schedule repair of erosion site prior to the next inspection.					
Inspector Comment

View of the erosion on the levee slope.

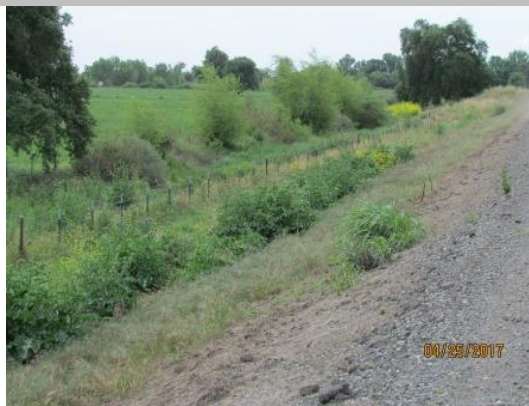
Photo 1 of 1 : SP_2017_RD2031_307_72_20170427_00125.jpg

LM Start	5.33	Rating **	M	Issue No.	72
LM End	5.77	Issue Type +	Ma	Location *	LS
Category	Earthen Levee			GPS Latitude/Longitude	
				Start	End
Item	Vegetation			37.677907 °	37.671800 °
				-121.217482 °	-121.218800 °
DWR ID	DWR_RD2031_01_s_2017_72				
Comment Code					
V1 : Control annual grass and weeds on the levee slopes and easements.					
Inspector Comment

View of the vegetation on the levee slope.

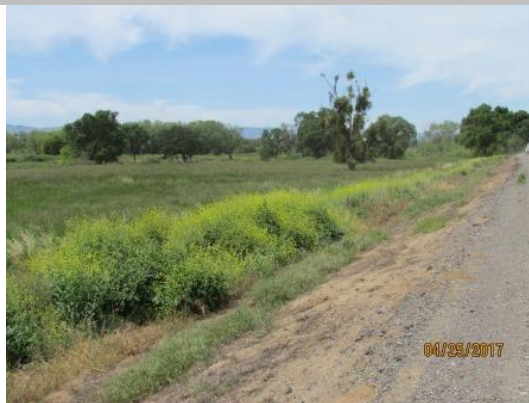
Photo 1 of 1 : SP_2017_RD2031_307_73_20170427_00126.jpg

LM Start	6.07	Rating **	M	Issue No.	73
LM End	6.89	Issue Type +	Ma	Location *	LS
Category	Earthen Levee			GPS Latitude/Longitude	
				Start	End
Item	Vegetation			37.669094 °	37.661802 °
				-121.222158 °	-121.229887 °
DWR ID	DWR_RD2031_01_s_2017_73				
Comment Code					
V1 : Control annual grass and weeds on the levee slopes and easements.					
Inspector Comment

View of the vegetation on the levee slope.

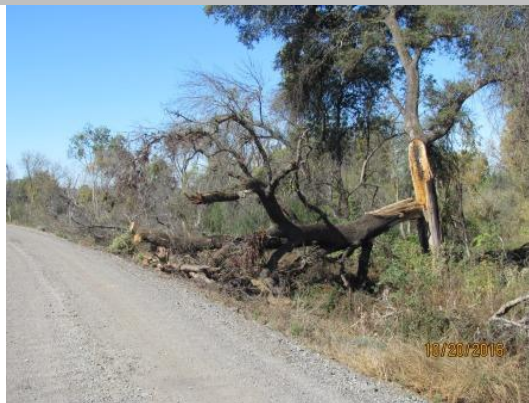
Photo 1 of 1 : SP_2017_RD2031_307_56_20170407_00039.jpg

LM Start	6.27	Rating **	M	Issue No.	56
LM End	6.27	Issue Type +	Ma	Location *	WS
Category	Earthen Levee			GPS Latitude/Longitude	
				Start	End
Item	Encroachments			37.668979 °	37.668979 °
				-121.225766 °	-121.225766 °
DWR ID	DWR_RD2031_01_f_2016_56				
Comment Code					
TR : Tree or limb					
Inspector Comment

View of the broken tree limb on the levee slope.

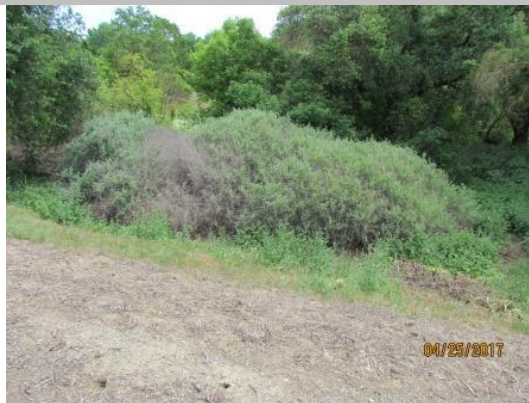
Photo 1 of 1 : SP_2017_RD2031_308_20_20170427_00045.jpg

LM Start	0.18	Rating **	U	Issue No.	20
LM End	0.18	Issue Type +	Ma	Location *	LS
Category	Earthen Levee			GPS Latitude/Longitude	
				Start	End
Item	Vegetation			37.659394 °	37.659394 °
				-121.234020 °	-121.234020 °
DWR ID	DWR_RD2031_02_s_2017_20				
Comment Code					
V2 : Remove the wild growth other than native grasses from the levee slopes.					
Inspector Comment					
Remove shrubs from levee toe to allow visibility and access.

View of the dense shrubs at the levee toe.

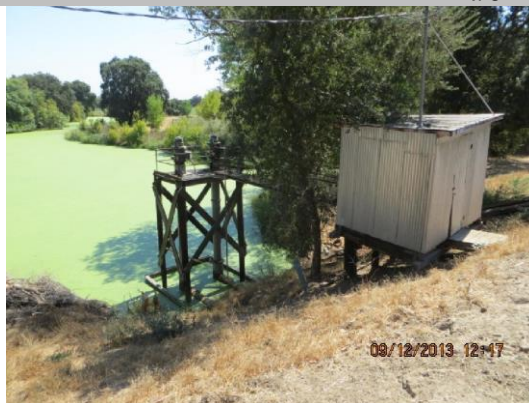
Photo 1 of 3 : UCIP_SP_2017_20703_34822.jpg

LM Start	0.22	Rating **	A/W	Issue No.	967
LM End	0.22	Issue Type +	Ma	Location *	LS
Category	Supplemental			GPS Latitude/Longitude	
				Start	End
Item	DWR UCIP LMA Responsibility			37.658888 °	37.658888 °
				-121.234274 °	-121.234274 °
DWR ID					
Comment Code					
Inspector Comment					
FS_ID:20703 DS_ID:20482 EP_NO: N/A Repair Type: No Action Needed Crossing Status: Found UCIP Comments: FIELD_STRUCT_DESC: 1 of 2: 24-inch steel pipe through levee 3.6 feet below crown. Concrete "U"-shaped headwall on the waterward end. Flap gates on the waterward end. Pump on pile structure on the landward side. Originally included in the 1968 O&M manual. FS Date: 9/12/2013

Pump on platform at LS toe.

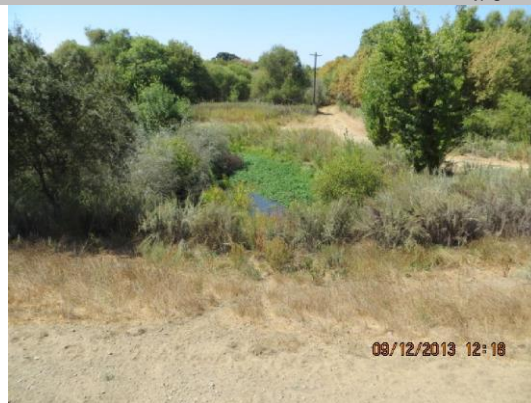
Photo 2 of 3 : UCIP_SP_2017_20703_34821.jpg

Pond at outlet on WS toe.

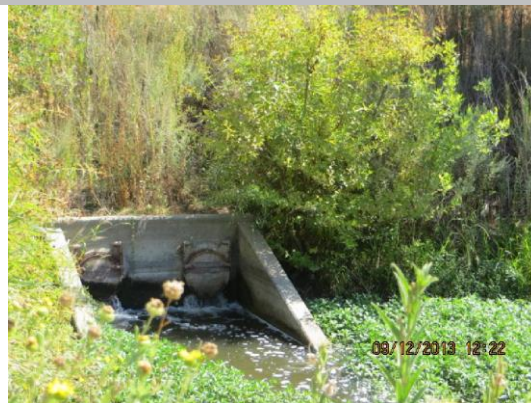
Photo 3 of 3 : UCIP_SP_2017_20703_34820.jpg

Concrete U-shaped headwall with flapgate on WS toe.

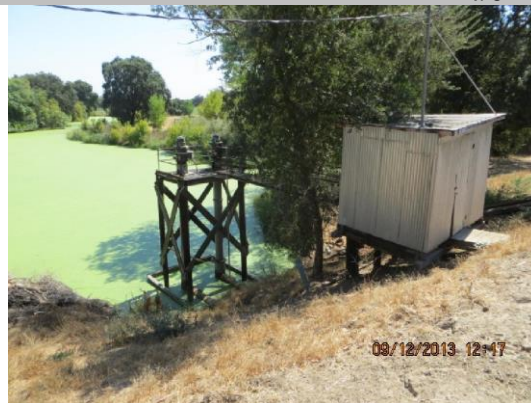
Photo 1 of 3 : UCIP_SP_2017_20704_34826.jpg

LM Start	0.22	Rating **	A/W	Issue No.	968
LM End	0.22	Issue Type +	Ma	Location *	LS
Category	Supplemental			GPS Latitude/Longitude	
				Start	End
Item	DWR UCIP LMA Responsibility			37.658875 °	37.658875 °
				-121.234280 °	-121.234280 °
DWR ID					
Comment Code					
Inspector Comment					
FS_ID:20704 DS_ID:20508 EP_NO: N/A Repair Type: No Action Needed Crossing Status: Found UCIP Comments: FIELD_STRUCT_DESC: 2 of 2: 24-inch steel pipe through levee 3.6 feet below crown. Concrete "U" headwall on the waterward end and concrete headwall at LS toe. Flap gate on the waterward end. Pump on pile structure on the landward side. Originally included in the 1968 O&M manual. FS Date: 9/12/2013

Pump on pier on LS toe with shed at pump walkway.

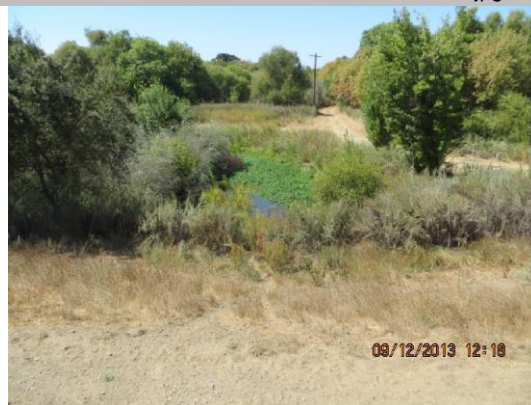
Photo 2 of 3 : UCIP_SP_2017_20704_34825.jpg

Pond at outlet on WS toe.

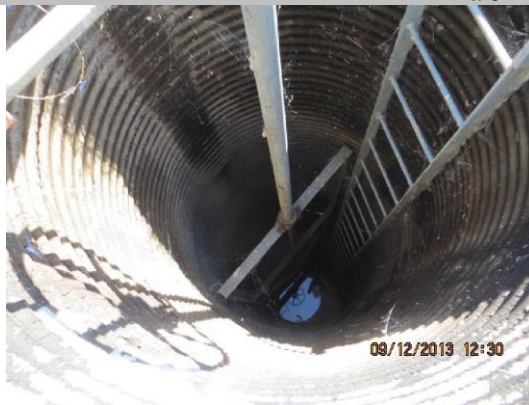
Photo 1 of 3 : UCIP_SP_2017_20708_34834.jpg

LM Start	0.24	Rating **	M	Issue No.	969
LM End	0.24	Issue Type +	Ma	Location *	LS
Category	Supplemental			GPS Latitude/Longitude	
				Start	End
Item	DWR UCIP LMA Responsibility			37.658595 °	37.658595 °
				-121.234410 °	-121.234410 °
DWR ID					
Comment Code					
Inspector Comment					
FS_ID:20708 DS_ID:20484 EP_NO: N/A Repair Type: Non-Urgent Crossing Status: Found UCIP Comments: Inlet filled with soil, and CMP riser on WS slope needs lid as it may be a hazard. FIELD_STRUCT_DESC: 48-inch corrugated metal pipe through levee 22.8 feet below crown. Slide gate in 5-foot diameter corrugated metal pipe riser on the waterward slope. Concrete "U" headwall on both ends. Flap gate on the waterward end. Originally included in the 1968 O&M manual. FS Date: 9/17/2013

Slide gate in CMP riser on WS slope.

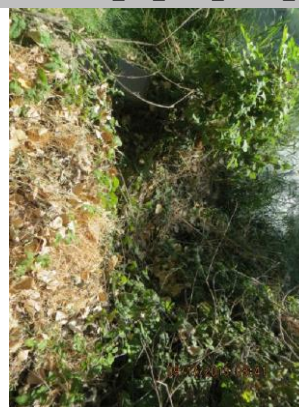
Photo 3 of 3 : UCIP_SP_2017_20708_34832.jpg

Concrete headwall on LS toe at edge of pond.

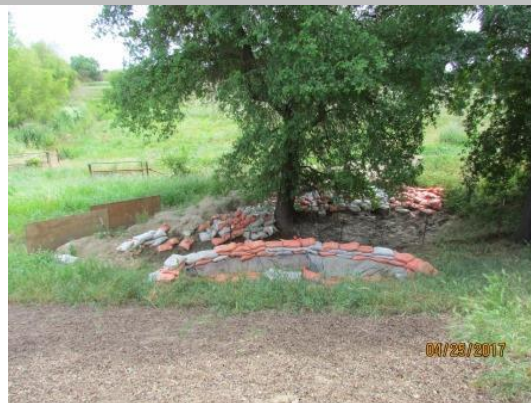
Photo 1 of 1 : SP_2017_RD2031_308_22_20170427_00046.jpg

LM Start	0.33	Rating **	U	Issue No.	22
LM End	0.33	Issue Type +	Ob	Location *	LS
Category	Earthen Levee			GPS Latitude/Longitude	
				Start	End
Item	Seepage / Sandboils			37.657380 °	37.657380 °
				-121.235006 °	-121.235006 °
DWR ID	DWR_RD2031_02_s_2017_22				
Comment Code					
Inspector Comment

View of the sack rings at the levee toe.

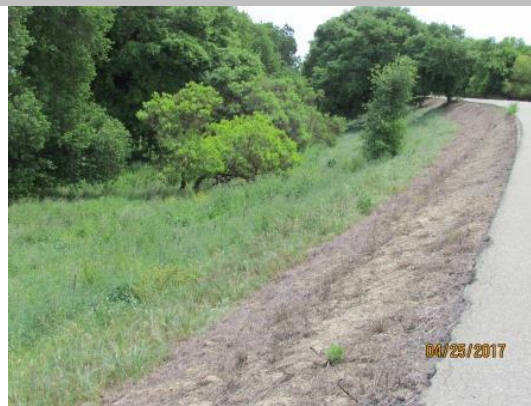
Photo 1 of 1 : SP_2017_RD2031_308_23_20170427_00047.jpg

LM Start	0.46	Rating **	M	Issue No.	23
LM End	0.46	Issue Type +	Ma	Location *	LS
Category	Earthen Levee			GPS Latitude/Longitude	
				Start	End
Item	Vegetation			37.655708 °	37.655708 °
				-121.234404 °	-121.234404 °
DWR ID	DWR_RD2031_02_s_2017_23				
Comment Code					
V1 : Control annual grass and weeds on the levee slopes and easements.					
Inspector Comment

View of the vegetation on the levee slope.

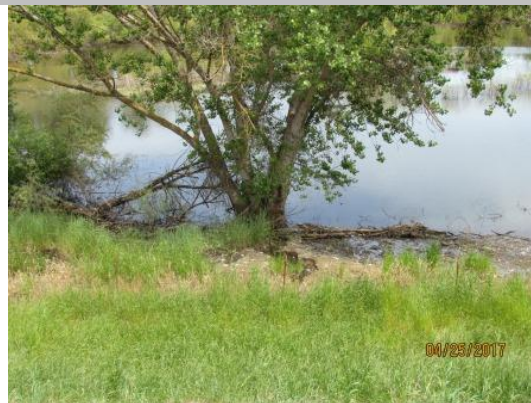
Photo 1 of 1 : SP_2017_RD2031_308_24_20170427_00048.jpg

LM Start	0.75	Rating **	U	Issue No.	24
LM End	1.11	Issue Type +	Ob	Location *	LS
Category	Earthen Levee			GPS Latitude/Longitude	
				Start	End
Item	Seepage / Sandboils			37.653954 °	37.651915 °
				-121.229623 °	-121.223617 °
DWR ID	DWR_RD2031_02_s_2017_24				
Comment Code					
Inspector Comment

View of the seepage at the levee toe.

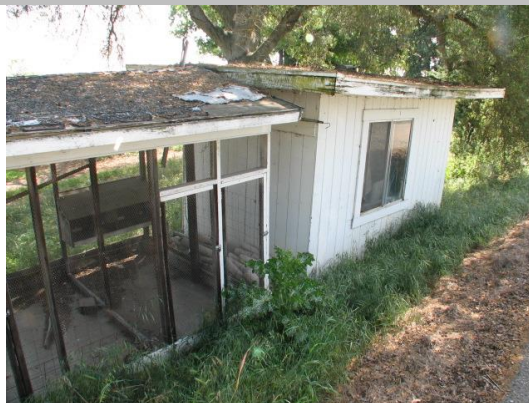
Photo 1 of 1 : SP_2017_RD2031_308_4_20170407_00004.jpg

LM Start	1.35	Rating **	U	Issue No.	4
LM End	1.35	Issue Type +	En	Location *	LS
Category	Earthen Levee			GPS Latitude/Longitude	
				Start	End
Item	Encroachments			37.648898 °	37.648898 °
				-121.221621 °	-121.221621 °
DWR ID	DWR_RD2031_02_s_2012_4				
Comment Code					
BU : Building					
Inspector Comment

Small structure on levee slope.

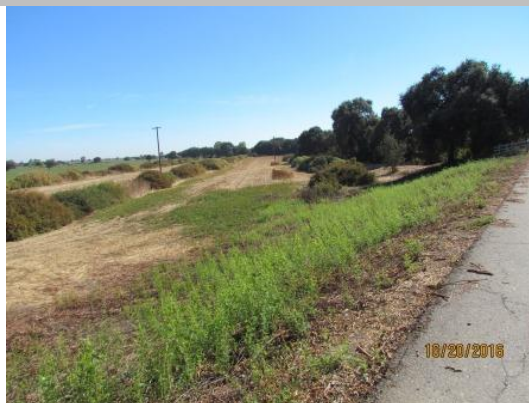
Photo 1 of 2 : SP_2017_RD2031_308_965_20170407_00009.jpg

LM Start	1.42	Rating **	A/W	Issue No.	965
LM End	1.46	Issue Type +	Ma	Location *	LS
Category	Earthen Levee			GPS Latitude/Longitude	
				Start	End
Item	Vegetation			37.648005 °	37.647476 °
				-121.221039 °	-121.220766 °
DWR ID	DWR_RD2031_02_s_2012_965				
Comment Code					
V2 : Remove the wild growth other than native grasses from the levee slopes.					
Inspector Comment					
Wild rose bush on landside slope. LMA mowed the shrubs in fall 2016. Site must be maintained or shrubs will grow back.

View of wild rose emerging on levee slope. Fall 2016.

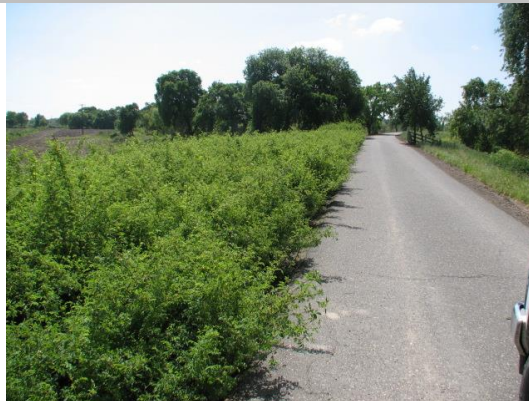
Photo 2 of 2 : SP_2017_RD2031_308_965_20170407_00010.jpg

Wild rose on levee slope.

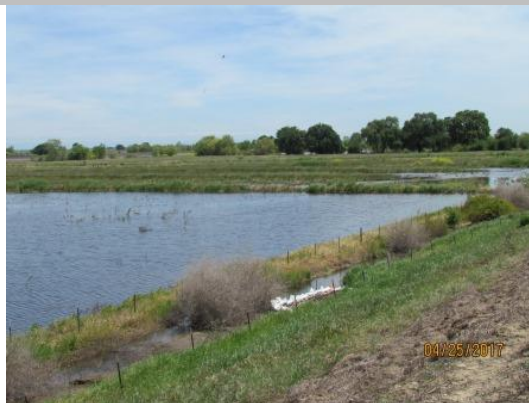
Photo 1 of 2 : SP_2017_RD2031_308_27_20170427_00049.jpg

LM Start	1.58	Rating **	U	Issue No.	27
LM End	2.33	Issue Type +	Ob	Location *	LS
Category	Earthen Levee			GPS Latitude/Longitude	
				Start	End
Item	Seepage / Sandboils			37.645656 °	37.640520 °
				-121.220463 °	-121.218078 °
DWR ID	DWR_RD2031_02_s_2017_27				
Comment Code					
Inspector Comment

View of the seepage and boils at the levee toe.

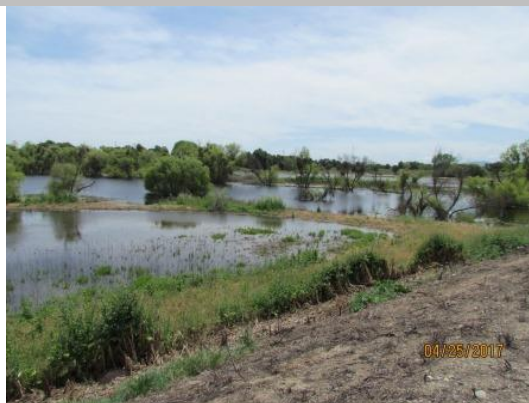
Photo 2 of 2 : SP_2017_RD2031_308_27_20170427_00050.jpg

Another view of the seepage at the levee toe.
